INSPECTION REPORT

1. INSPECTION INFORMATION	
Client:	eWheels LLC
Supplier:	BEGODE
Factory:	BEGODE
Product:	UNICYCLES
P.O. No.:	NA
P.O. Quantity:	30 PCS
Item No.:	Miten5P
Inspection Date:	2024-08-22
Location:	Dongguan City, Guangdong Province, China
Inspector:	Rocky Liu

Service	Pre-shipment Inspection		
Report No.	V-2408594		
Date Issued	2024-08-24	P 2 / 16

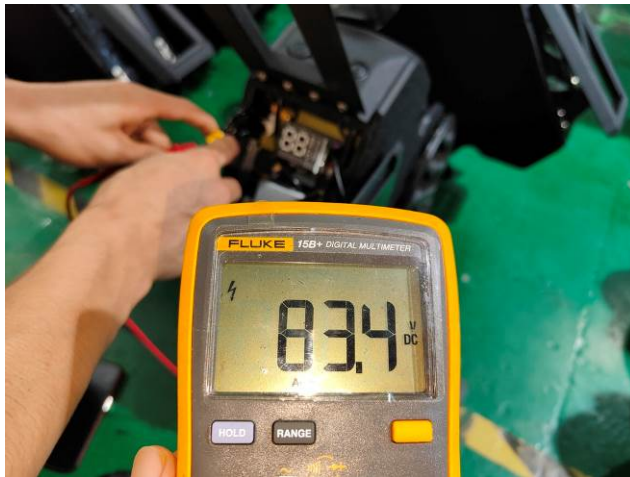
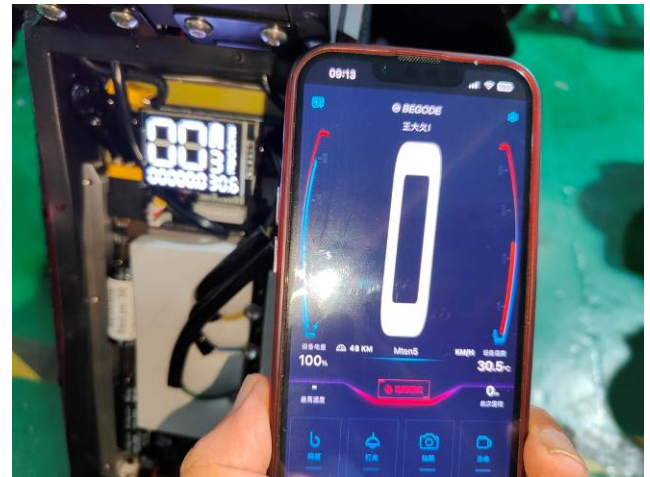
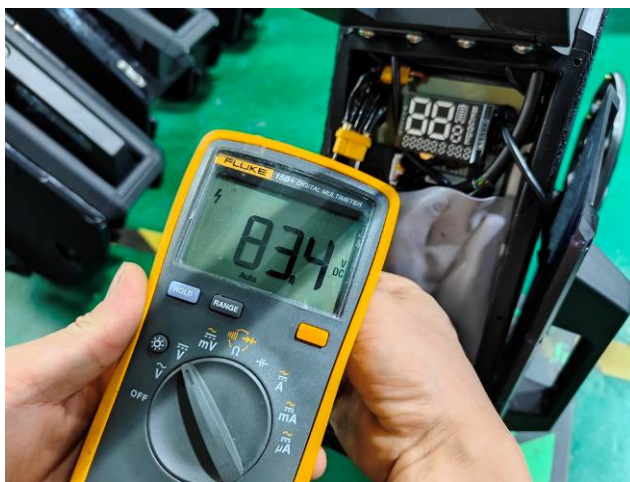
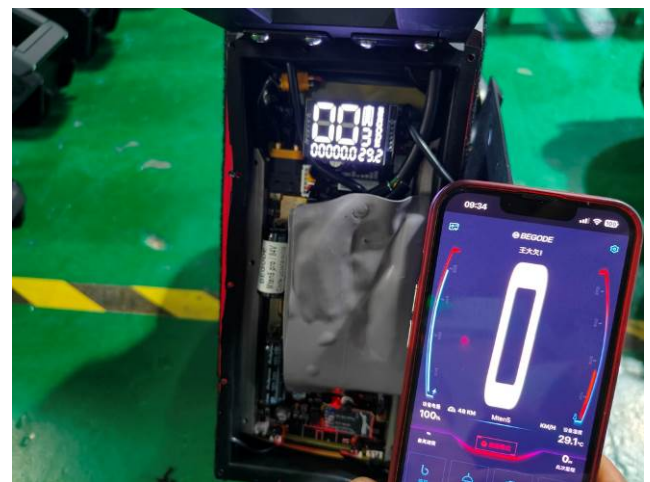
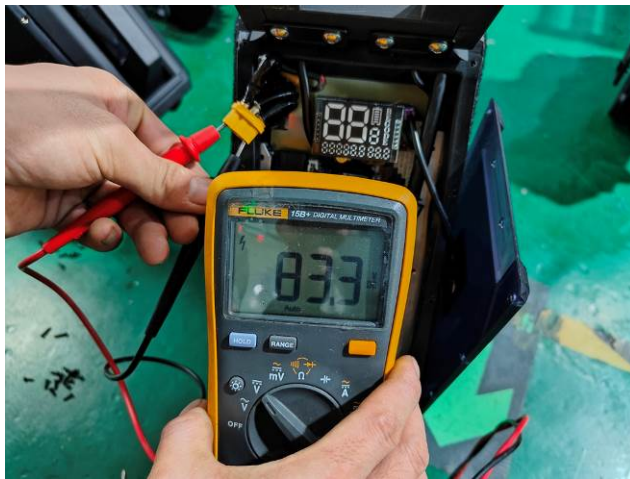
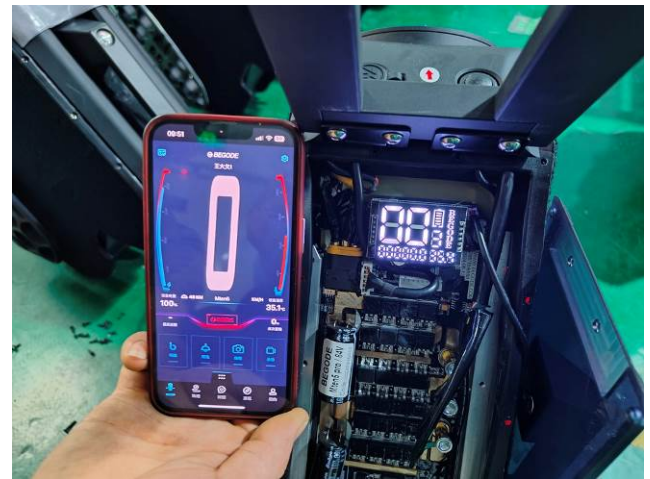
Actual Checked Battery Voltage against Voltage by App

3. REMARK POINT	
-	--
Check Points	
1	Battery voltage to full: When fully charged check whether the screen display voltage and the APP voltage can reach the marked voltage (tolerance +/- 0.5V). Additionally, test the actual voltage of 2 to 3 units (requiring disassembling the shell) to see the difference from the screen display voltage. Result:

Actual Checked:		Spec. 84v							
Miten5P	83.4	83.4	83.3	83.5	83.4	83.5	83.5	83.5	
By App:		APP only display 100%							
Miten5P	100%	100%	100%	100%	100%	100%	100%	100%

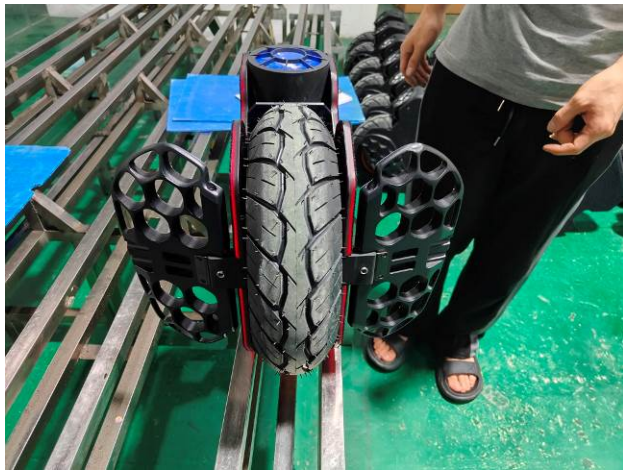
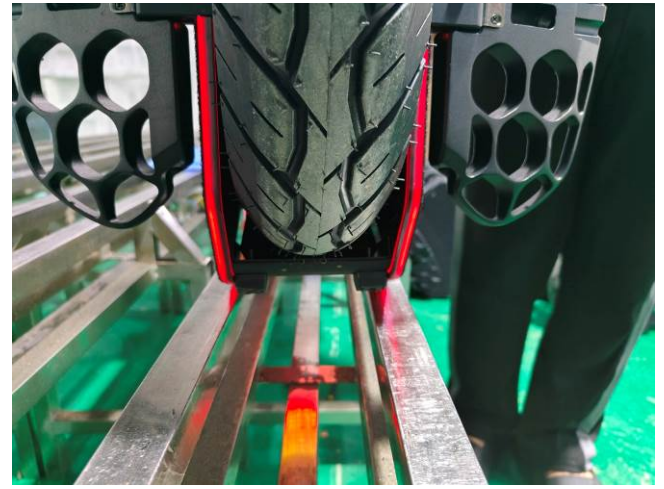
That tires are mounted centered on the rim, with lubricating compound applied, & that there is no rubbing against fender/shell.

Result: OK. Except with lubricating compound applied cannot be verified.

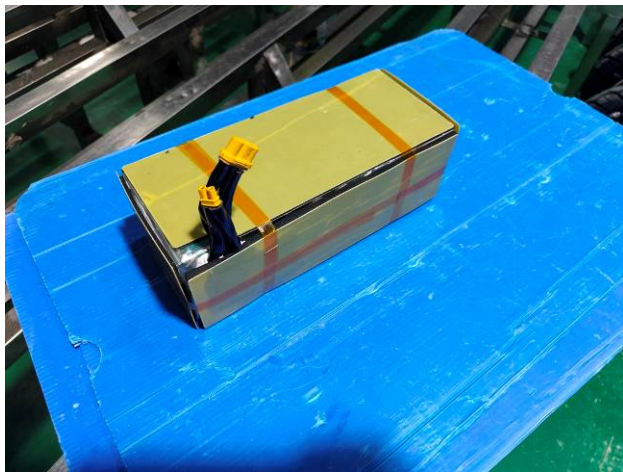
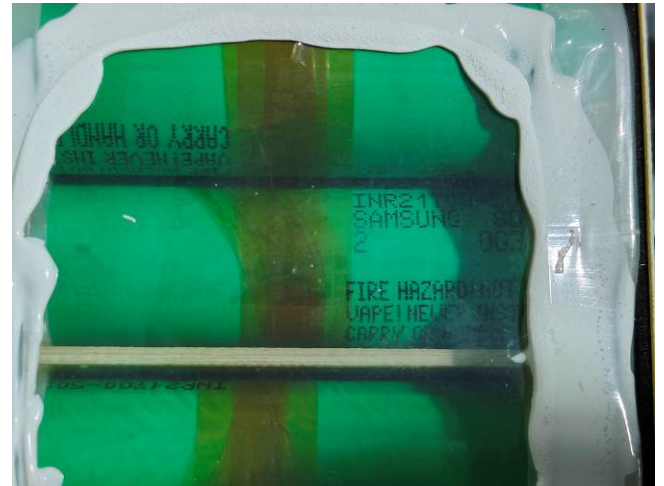
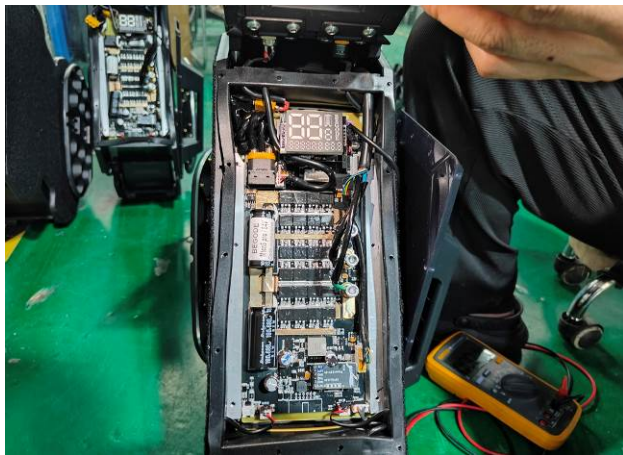
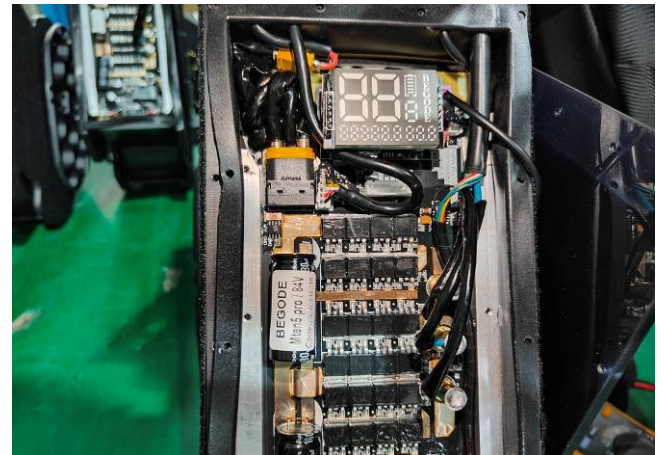
the main thing is checking that they're using the Samsung 50S battery cells & the upgraded 24x MOSFET controller.

Result: OK

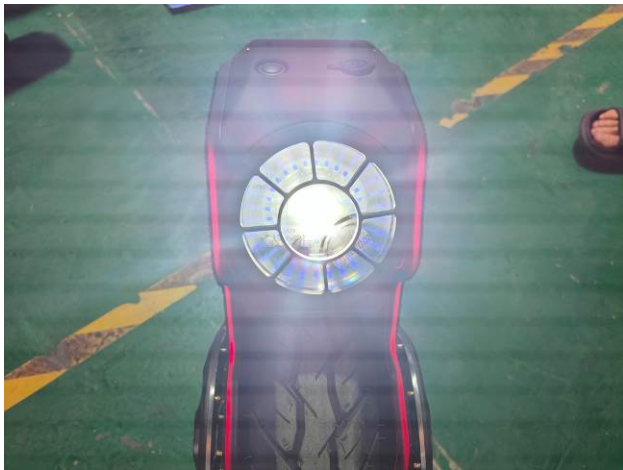
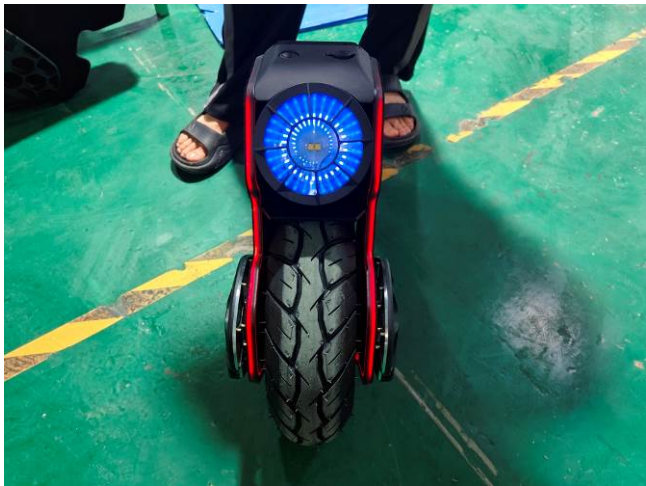
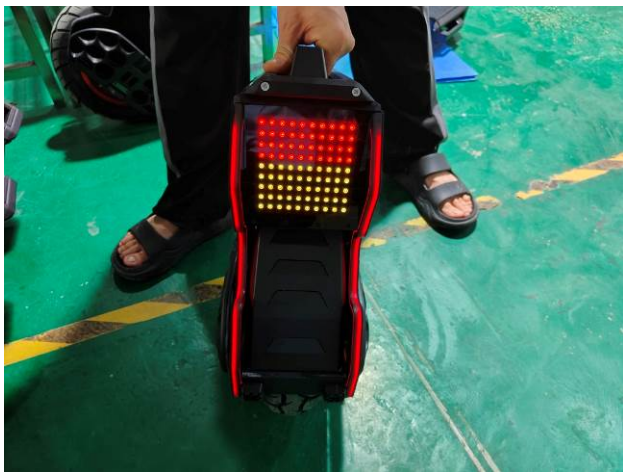
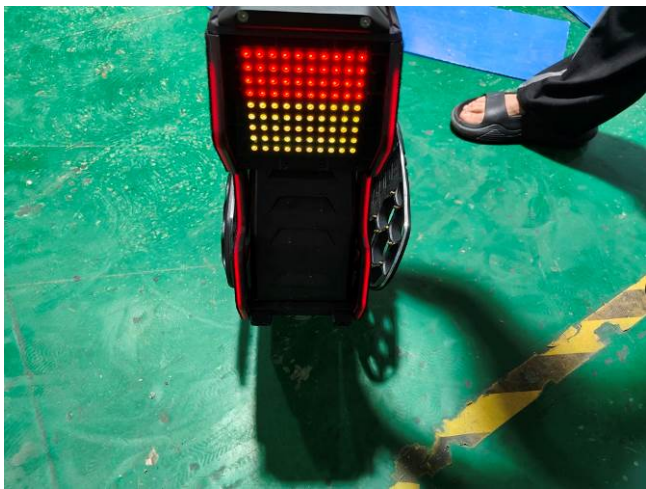
General Requirement	
1	All lights work Result: OK. refer to attached video.04

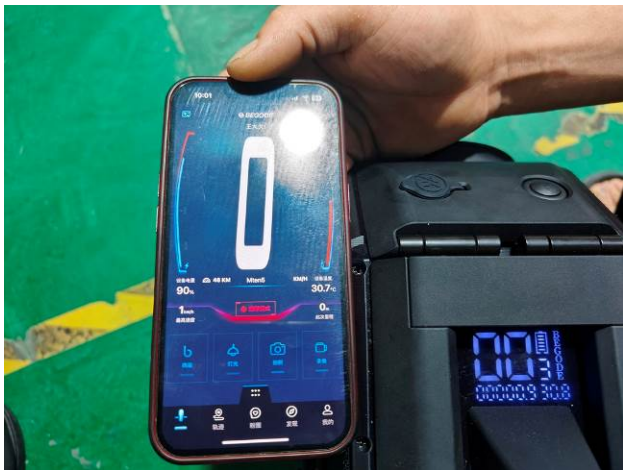
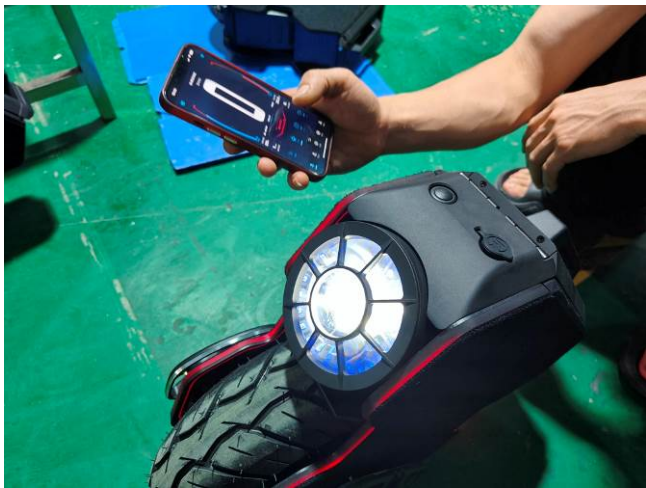
Connectivity to the App.  
Result: ok refer to attached video.03

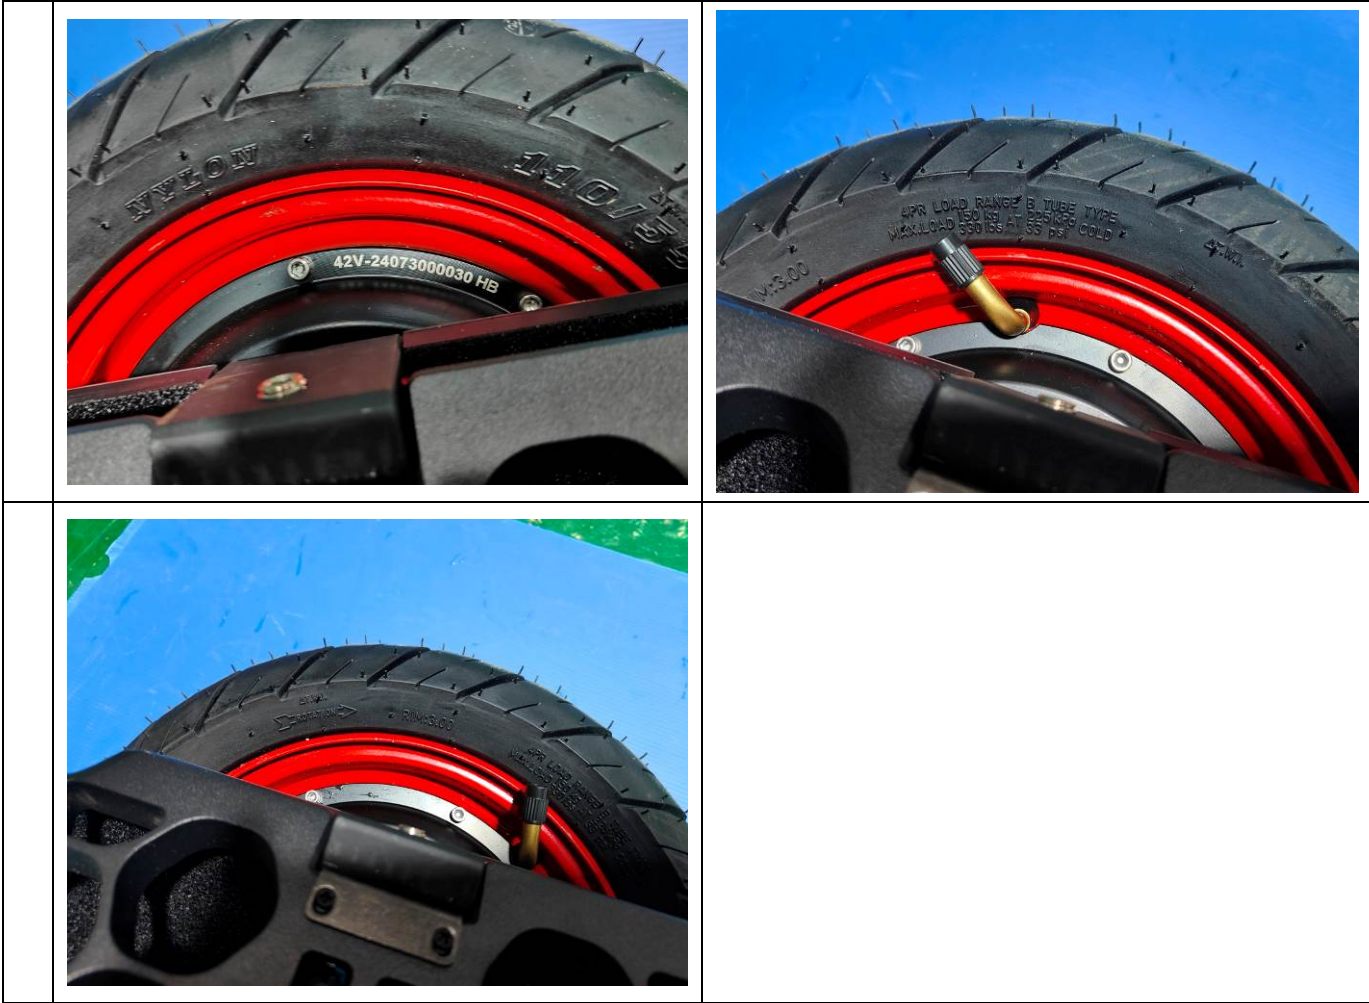
<p>The specification parameters and brand on the tire was photographed.</p> <p>Result: ok</p>
5
