INSPECTION REPORT

1. INSPECTION INFORMATION	
Client:	eWheels LLC
Supplier:	BEGODE
Factory:	BEGODE
Product:	UNICYCLES
P.O. No.:	NA
P.O. Quantity:	30 PCS
Item No.:	Miten5P
Inspection Date:	2024-08-22
Location:	Dongguan City, Guangdong Province, China
Inspector:	Rocky Liu

Service	Pre-shipment Inspection		
Report No.	V-2408594		
Date Issued	2024-08-24	P 2 / 16

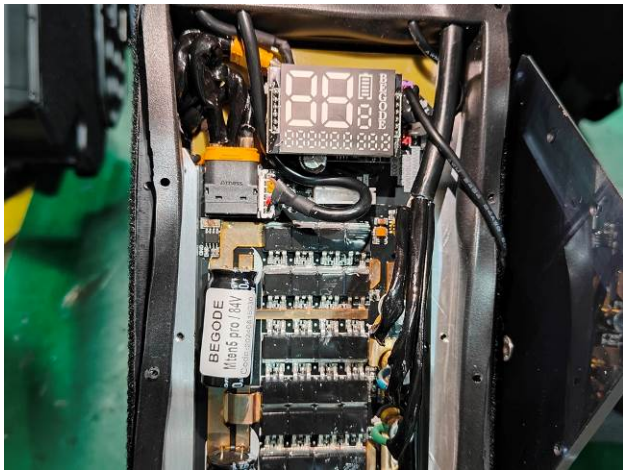
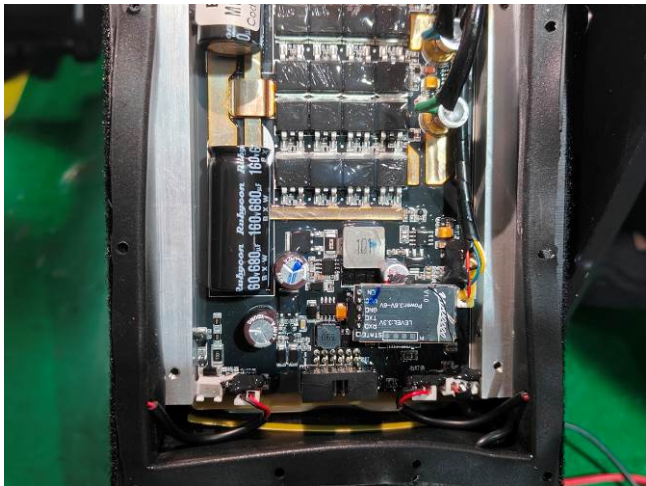
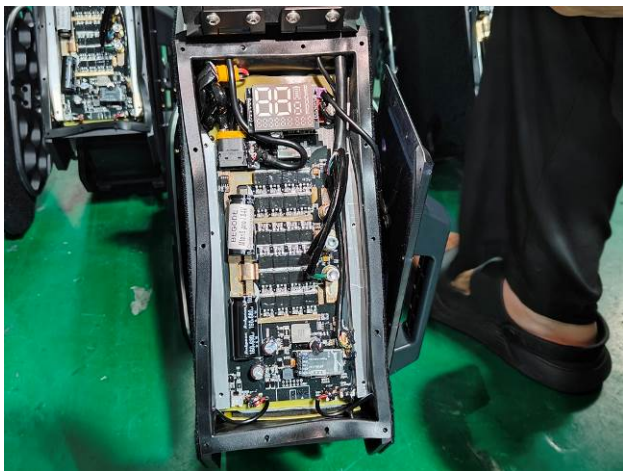
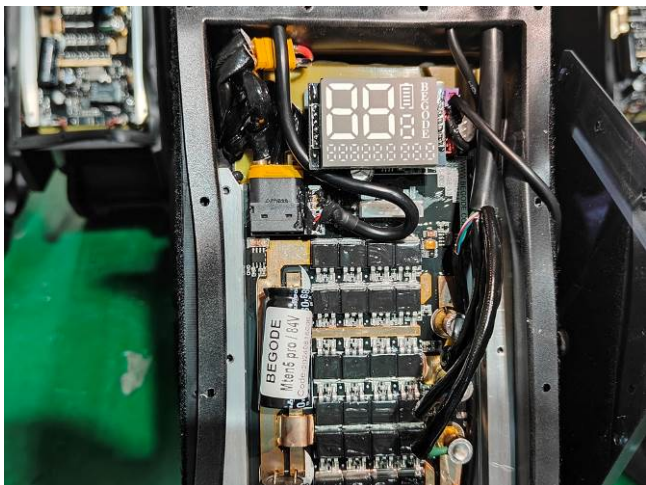
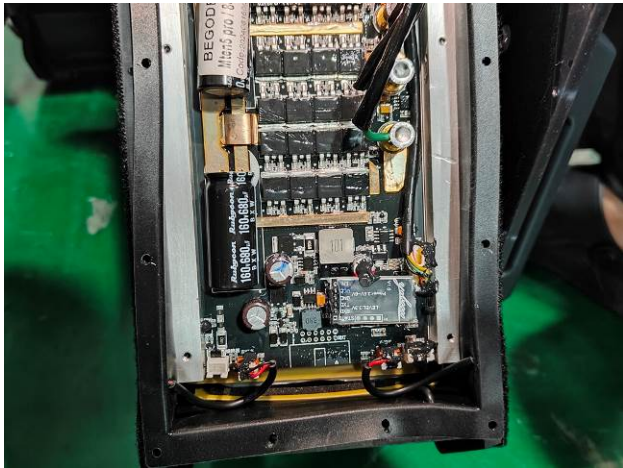
7	If there are any abnormalities, the serial numbers need to be recorded to ensure KS does not ship out identified problem cases. Result: OK.
